Time Dilation, Technical Dilation, and Corporate Dilation

TD Analysis Report

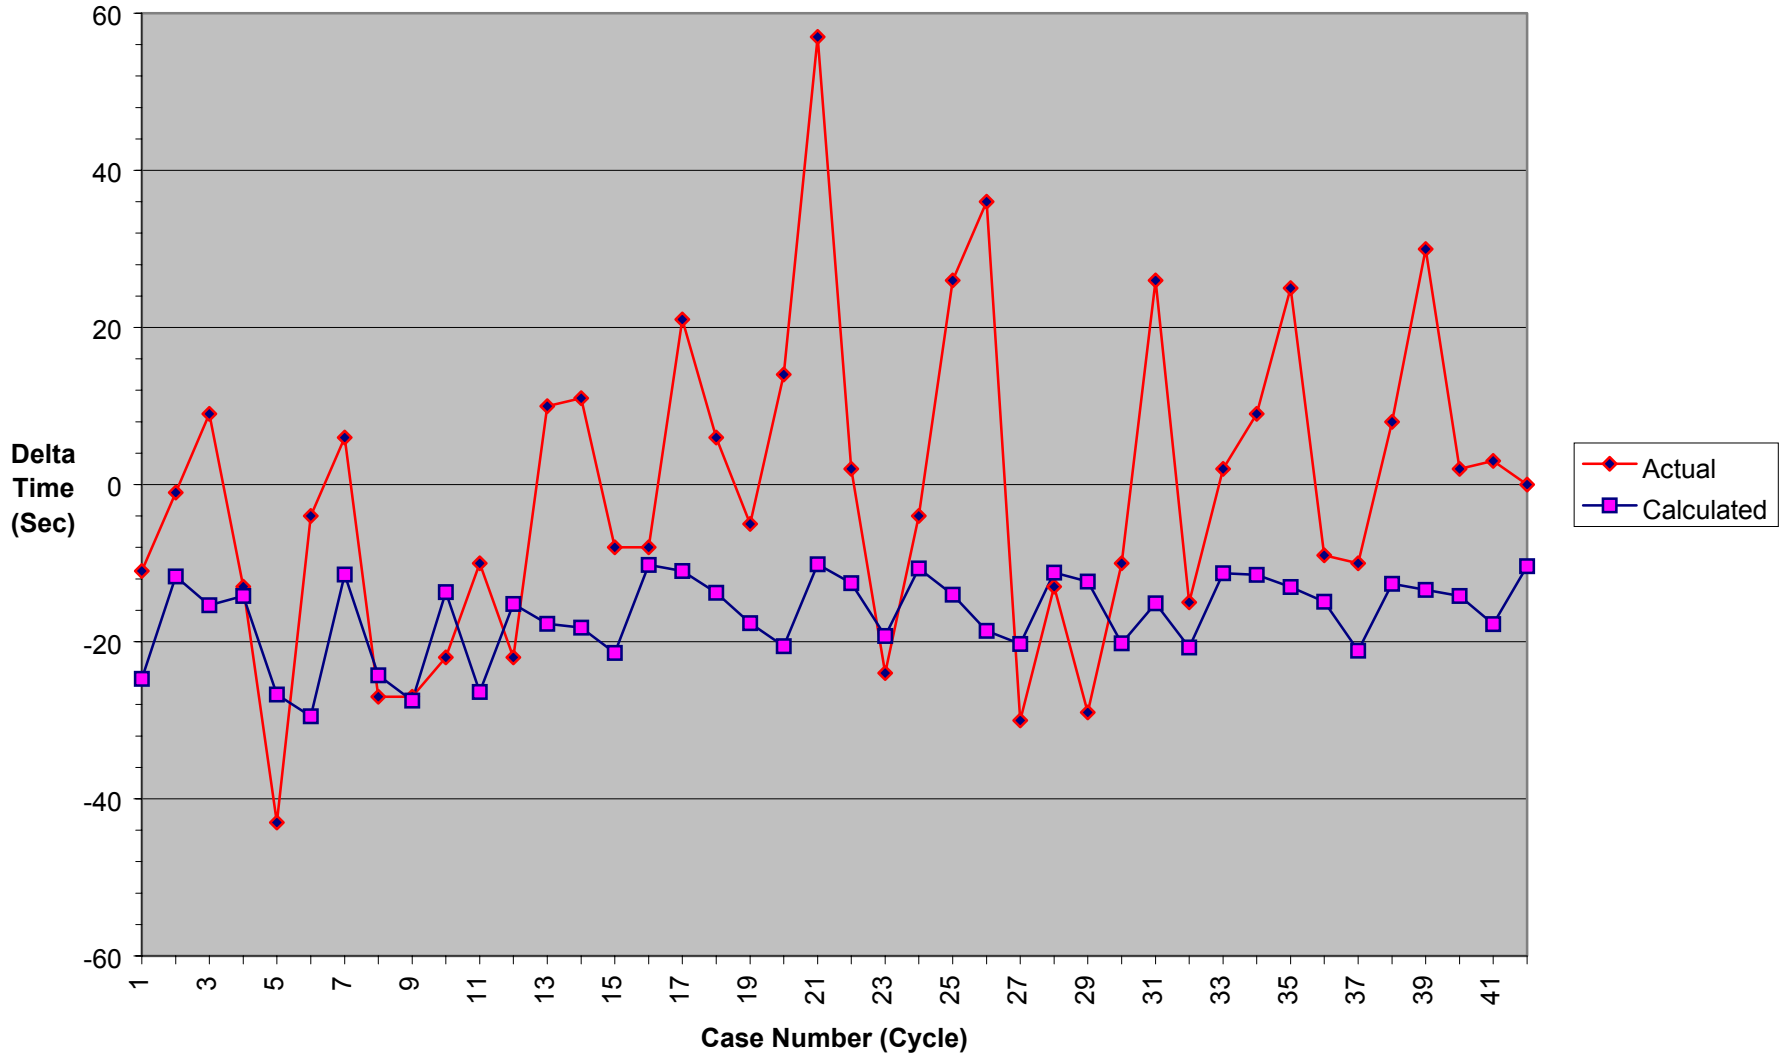
CHART 1: Test Data Results based on wristwatch reference set to 30 seconds of time

1. Where the time difference between Wristwatch Ref Date/Time and the Display Date/Time is greater than 59 seconds, the excess time cannot be reconciled for Intel's offset theory to be a valid cause of the anomaly. In fact, it is proof that in such cases a TD anomaly is being exhibited, and an *advanced* time anomaly is hard to disprove.
2. On close examination of Chart 1, the plotted red line very roughly follows the general pattern of the plotted blue line. This tends to support Intel's 0.036% offset theory as fact, as explained in this analysis.

7. The Zenith BIOS anomaly is *not* the cause of the TD anomaly, since the maximum offset error is no more than 31 seconds on any given day.

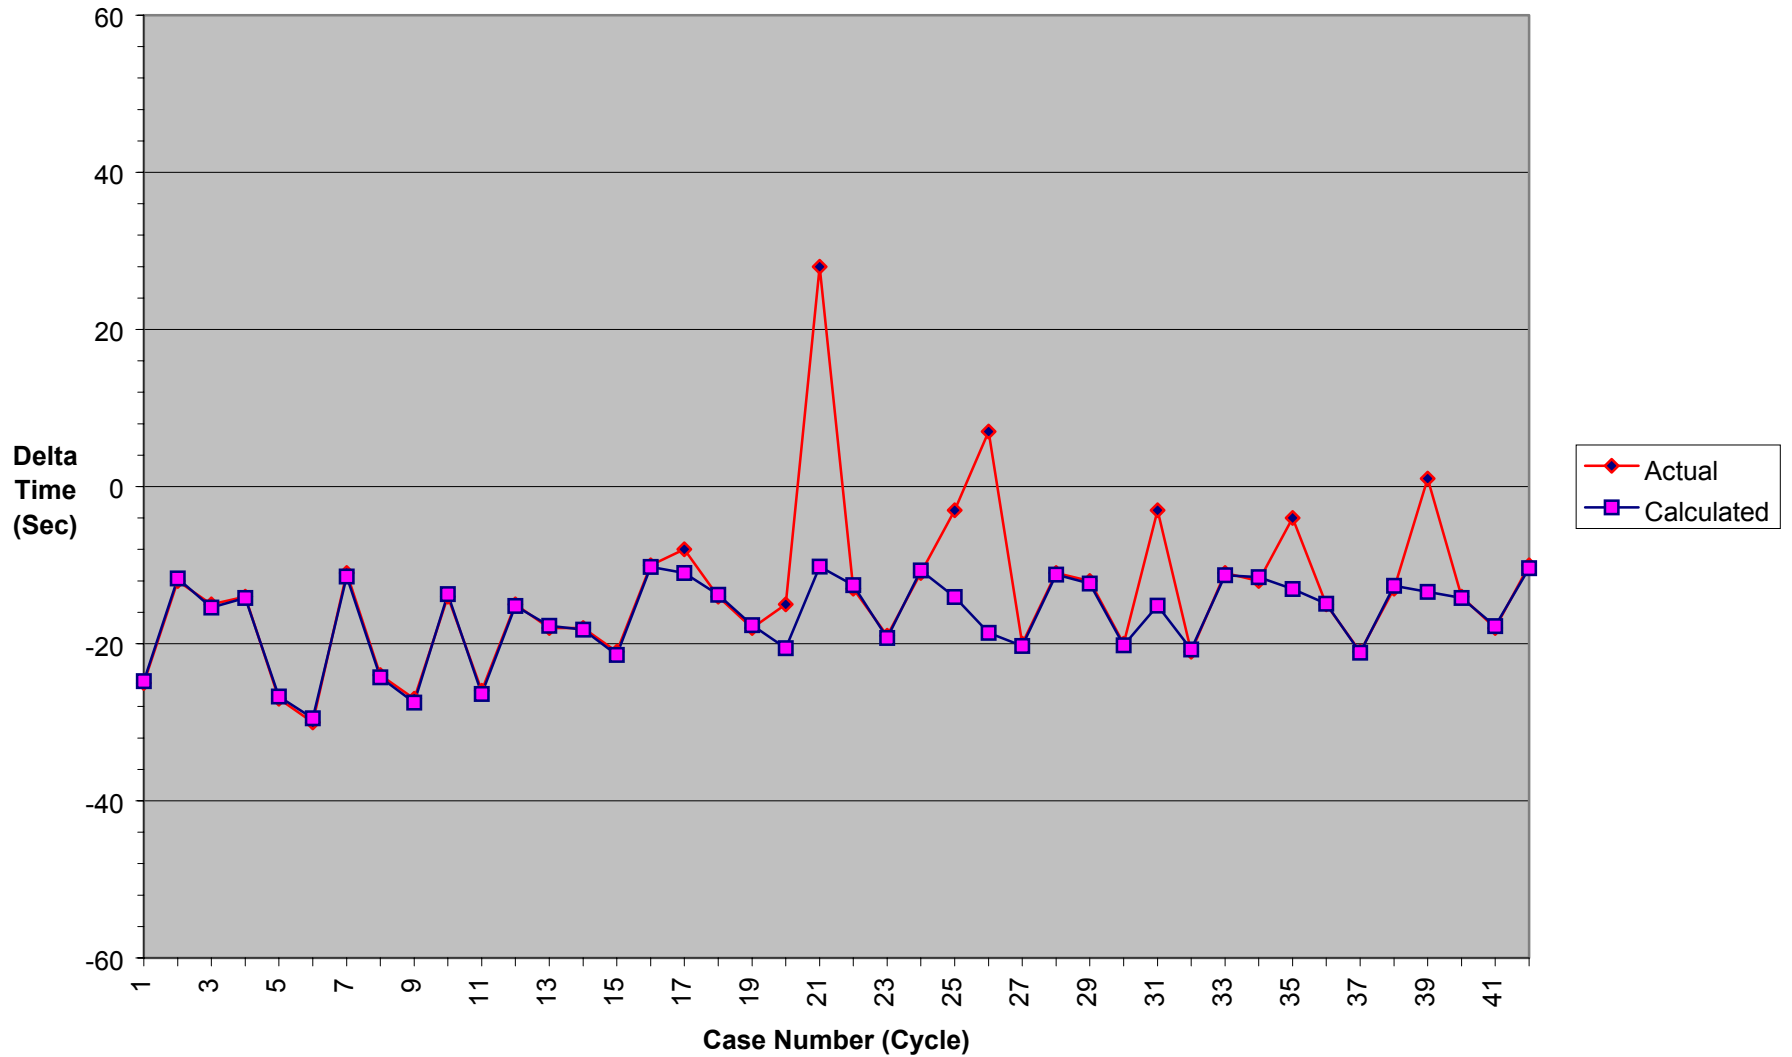
CHART 2: Adjusted Test Data Results based on reconstructed wristwatch seconds of time, Best Case Scenario

The foregoing analysis shows that all Case Numbers with advanced time anomalies fail to meet the blue plotted line regardless of the wristwatch reference seconds of time, as demonstrated by employing Figure 3 formula. This is true in both Tables 2 and 3 and respective Charts 2 and 3.

With this in mind, then, *all errant data points are positive* relative to the blue plotted line. Further, this is a consistent characteristic of the TD anomaly in this case. Theory #1 fits this scenario, while Theory #2 (I/O Delay) does not. Theory #1 guarantees consistent advanced time anomalies, while Theory #2 does not. Why? Because Theory #2 can cause the RTC address to point to some memory address whose data could result in a retrogressed time anomaly, which does not fit the characteristics described.
